**PROCEEDINGS OF THE 13th SYMPOSIUM
ON THE GEOLOGY OF THE BAHAMAS
AND OTHER CARBONATE REGIONS**

IMPACT OF THE SEPTEMBER 2, 2004 HURRICANE FRANCES ON THE COASTAL ENVIRONMENT OF SAN SALVADOR ISLAND, THE BAHAMAS

Tina M. Niemi, Jamie C. Thomason, Janice M. McCabe, and Alexander Daehne

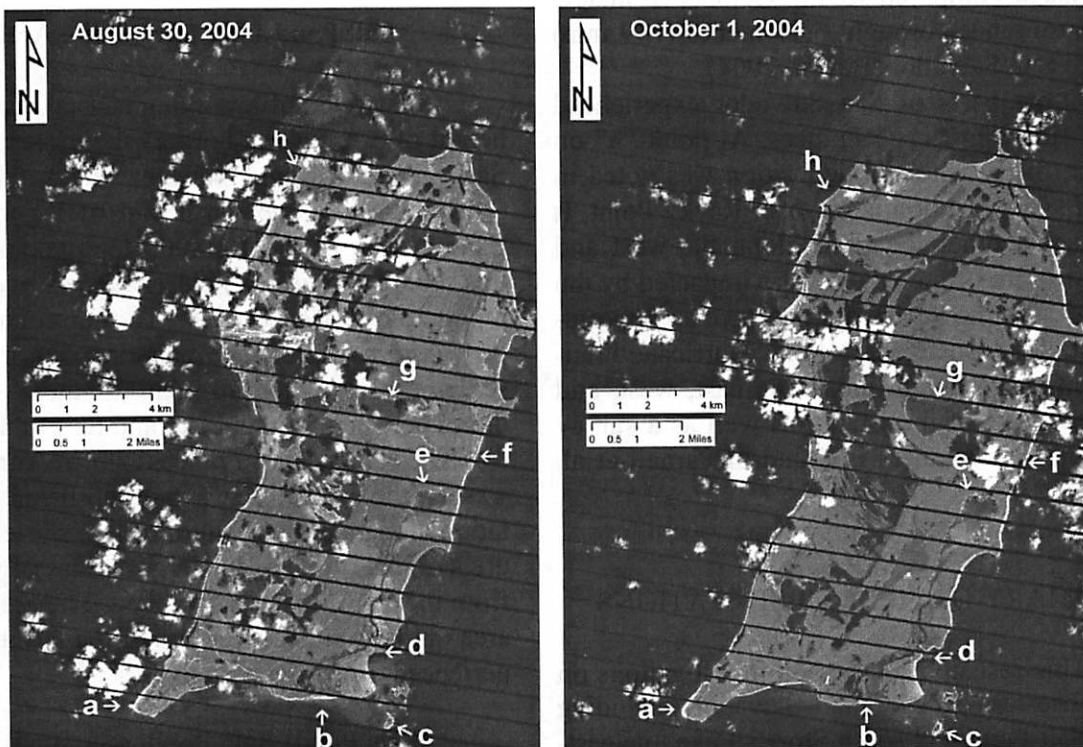
ual comparison of the pre- and post-Hurricane Frances images shows a pronounced reduction in the width of the Sandy Point beach. The onshore and offshore movement of sand and its control on beach width is a seasonal phenomenon. The beach narrows during the rainy season months of high intensity storms during September through November when erosion causes removal of sand and a scarp to form in the back beach area. The beach widens during the dry season months of December-August when sand deposition and beach bar accretion dominates the sedimentary processes. This has been previously documented for Sandy Point by repeated beach profiling (*e.g.* Loizeaux et al. 1993; Beavers et al., 1995; Curran et al., 2001). We also observed a very narrow beach and ~2-m-high erosional beach scarp at Sandy Point in March 2005 lasting well into the dry season. This observation indicates that Hurricane Frances and likely Hurricane Jeanne caused extensive erosion on this beach that had not yet recovered six months after the storms. Wide beaches were observed at Sandy Point in March 2007.

The Gulf is located on the southern part of the island where deep water lies close to the shoreline. The location of point "b" on Figure 2 shows the area where storm surge overwash inundated the southern part of Pigeon Creek. Comparison of the satellite images before and after Hurricane Frances shows that the width of the beach (zones of bright reflections) has narrowed. This is largely due to the massive movement of blocks and boulders of bedrock landward caused by the storm surge.

Low Cay is marked as point "c". Comparison of the images in Figure 2 show that the vegetated area of the island was sharply reduced by the hurricane. Large areas of defoliated vegetation and re-deposited sand are noted on the eastern side of the island.

Figure 2. Panchromatic images (Band 8) of San Salvador acquired by the Landsat 7 Enhanced Thematic Mapper Plus from before Hurricane Frances (left; August 30, 2004) and after (right image; October 1, 2004). Cloud cover shown as white spots. Image is annotated for special sites of interest: a=Sandy Point; b= The Gulf; c=Low Cay; d=Pigeon Creek inlet; e=north Pigeon Creek; f=Salt Pond; g=inland lake area; h=north Rocky Point. See text for discussion.

The northern end of the Pigeon Creek estuary is marked with the letter "e". The storm caused water to overtop the banks of this water body. The overwash deposition is shown as areas of bright reflections on the October 1, 2004 image (Figure 2).

Point "f" on Figure 2 is the location of Salt Pond. Like the other inland lakes, the levels of Salt Pond rose after the hurricane. The width of the de-vegetated beach also widened north of point "f".

One of the most pronounced differences between the August 30th and October 1st images is in the water level of the interior lakes. Point "g" on Figure 2 highlights only one of the many lakes. This lake is called Granny Lake. On the August image, the bright outlines around the lake mark the lowstand shoreline exposing the un-vegetated lake margins. Lake levels are markedly lower in all the lakes compared to the October 1 image. Hurricane Frances brought 5.47 inches (139 mm) of rain to San Salvador (Beven, 2004).

Other parts of San Salvador experienced impacts from Hurricane Frances. At point "h" on Figure 2, overwash sand deposition was noted in the field. This location is north of Rocky Point. It is likely that other locations along the west and northeast shore of the island were impacted by the hurricane. We, however, did not have an opportunity to study those areas. Data for Hurricane Frances storm surge height along the east, west, and southwest parts of the island, as well as a survey of damage to structures is found in Parnell et al. (2004).

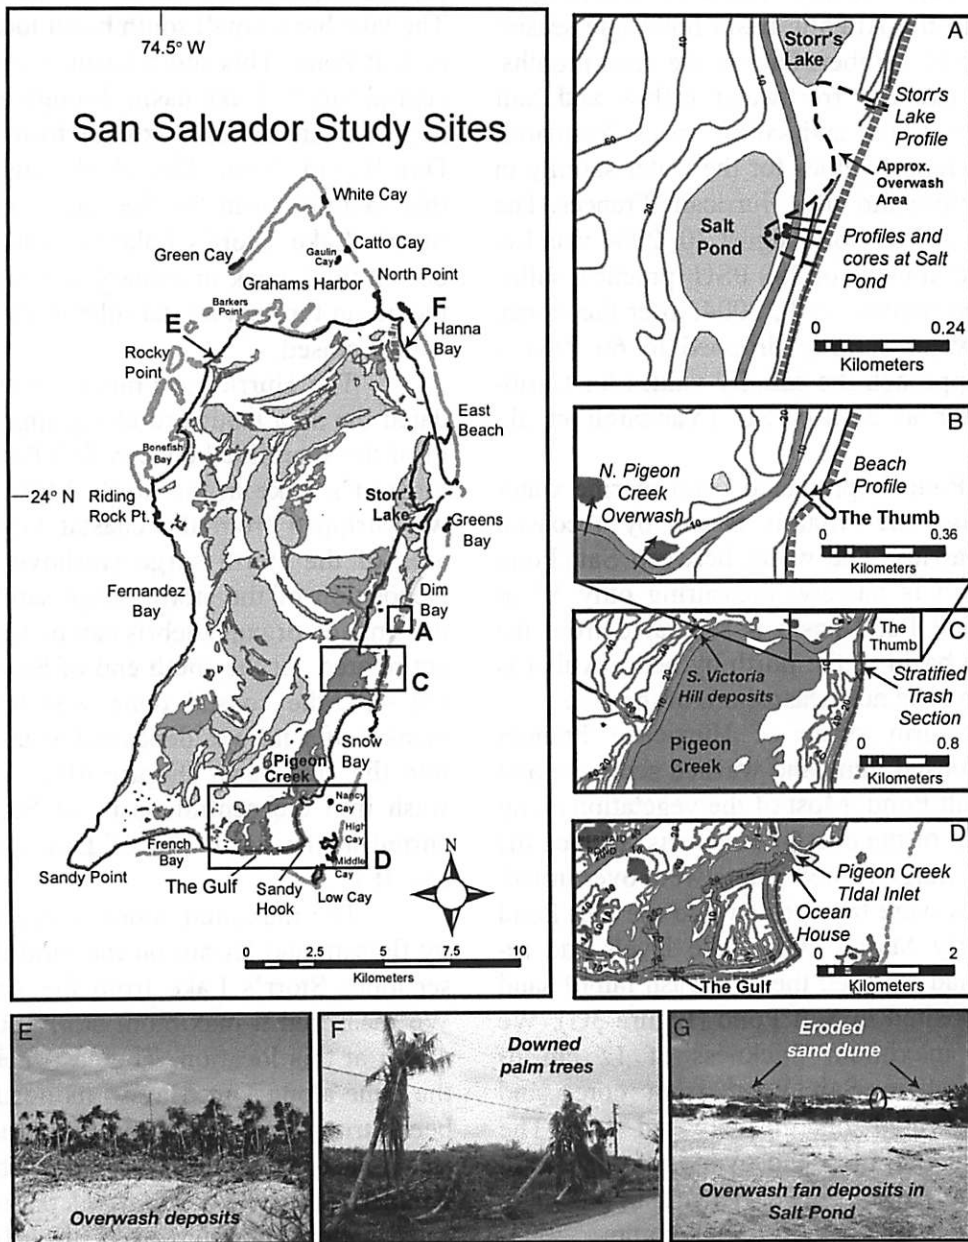
Figure 3: Map showing sites on the island of San Salvador, The Bahamas where damage from Hurricane Frances was documented in this study. Images are plotted from the GIS database of R. Laurence Davis and Matthew C. Robinson (1999, University of New Haven). A) Location of the overwash fan in Salt Pond and Storr's Lake and storm surge profiles and cores. B) Detailed map of 'The Thumb' showing location of beach profile. The overwash from north Pigeon Creek is also labeled. C) Map showing the location of storm surge height profiles at The Thumb and stratified trash section. D) Detail of the southeast section of San Salvador showing the location of Ocean House at the Pigeon Creek tidal inlet and overwash deposits at 'The Gulf'. E) Hurricane Frances also caused overwash deposition along the northwest part of the island. View toward the southeast. F) Four palm trees were blown down onshore of Hanna Bay. View toward the southeast. G) Photograph of the overwash fan deposits in Salt Pond viewed toward the east. The beach barrier sand dune was stripped of vegetation and eroded. Oval outlines a person for scale.

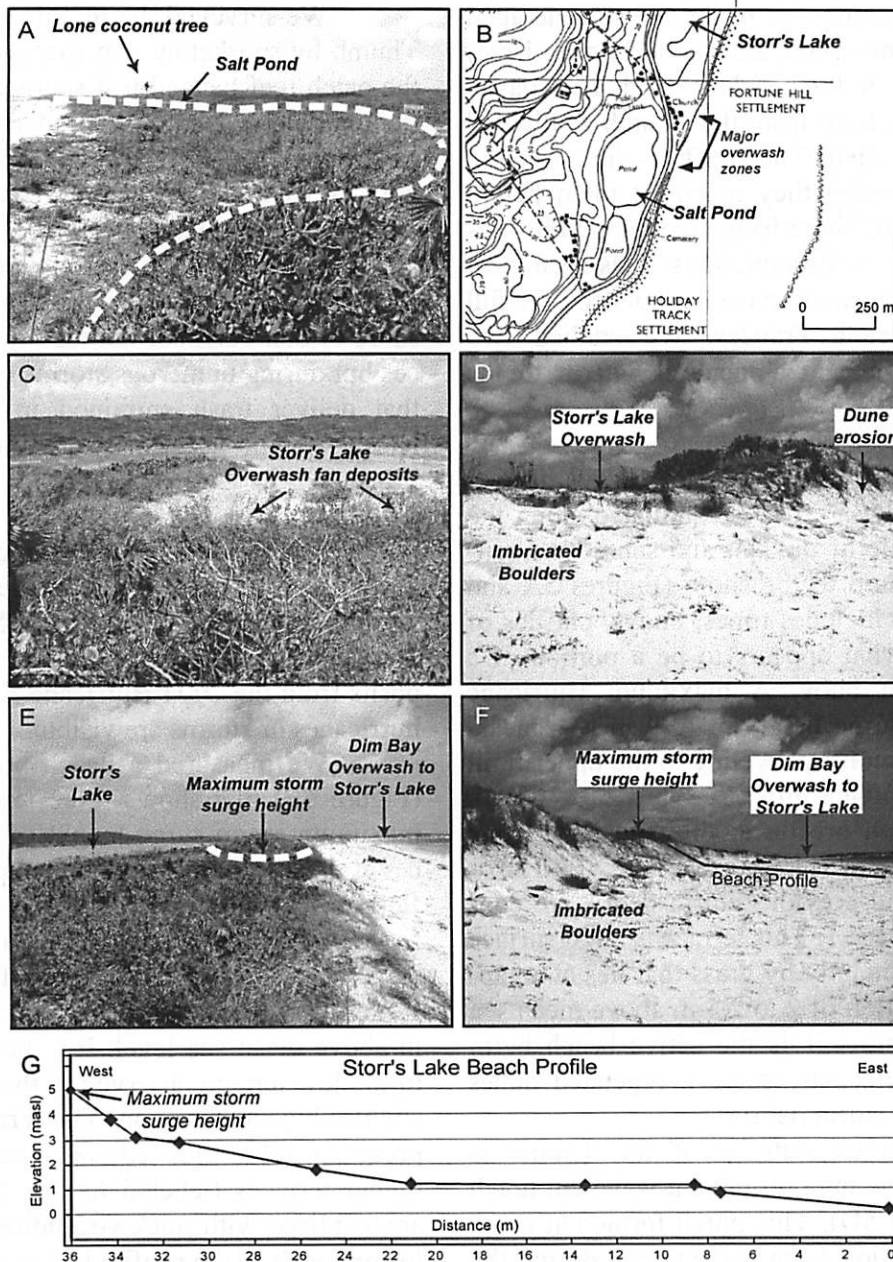
The Hurricane Frances storm surge inundated the area landward along approximately 300 m of the shoreline between Salt Pond in the south to Storr's Lake in the north. Most of the foliage was stripped from the coastal vegetation in the area of the storm surge washover (Figure 4A). Deposition of the storm surge sand, flotsam and jetsam, and organic debris can be traced along this entire area. At the south end of Storr's Lake (Figure 4C), the coastal dune was breached and a blanket of sand was deposited as an overwash fan into the lake basin (Figure 4D). A second overwash into the central basin of Storr's Lake occurred at the north end of Dim Bay (Figure 4E and 4F).

The maximum storm surge was identified by flotsam and jetsam on the sand dune crest that separates Storr's Lake from the Atlantic Ocean. We measured a maximum storm surge height of 4.8 m at this location. The east-facing portion of the dune along Dim Bay to its northern limit has been stripped of vegetation and eroded leaving a steep east-facing scarp. The storm transported boulders inland and deposited them in an imbricated pattern dipping east (seaward). These large imbricated slabs line the base of the sand dunes along this eastern shore (Figure 4F) and likely represent an accumulation of numerous storms in addition to Hurricane Frances.

Figure 4: Photographs of Hurricane Frances storm surge damage in the Fortune Hill Settlement area between Storr's Lake and Salt Pond. A) View south from Storr's Lake showing area of extensive washover and defoliated vegetation. B) A portion of the 1:10,000-scale topographic map showing the area around Salt Pond. C) The south end of Storr's Lake showing the overwash fan deposits. Vegetation in the foreground is defoliated. (View west). D) View northwest toward Storr's Lake showing the overwash breach, eroded dunes, and storm deposited imbricated boulders at the base of the sand dune. E) View north along the sand dune crest that separates Storr's Lake from the Atlantic Ocean. The location of the maximum storm surge height is marked. F) The eroded eastern side of the coastal sand dunes viewed north along Dim Bay. The maximum storm surge was identified by the upper limit of flotsam and jetsam deposited on the sand dune. G) Beach profile showing maximum storm surge height (4.8 m). Location of profile in F.

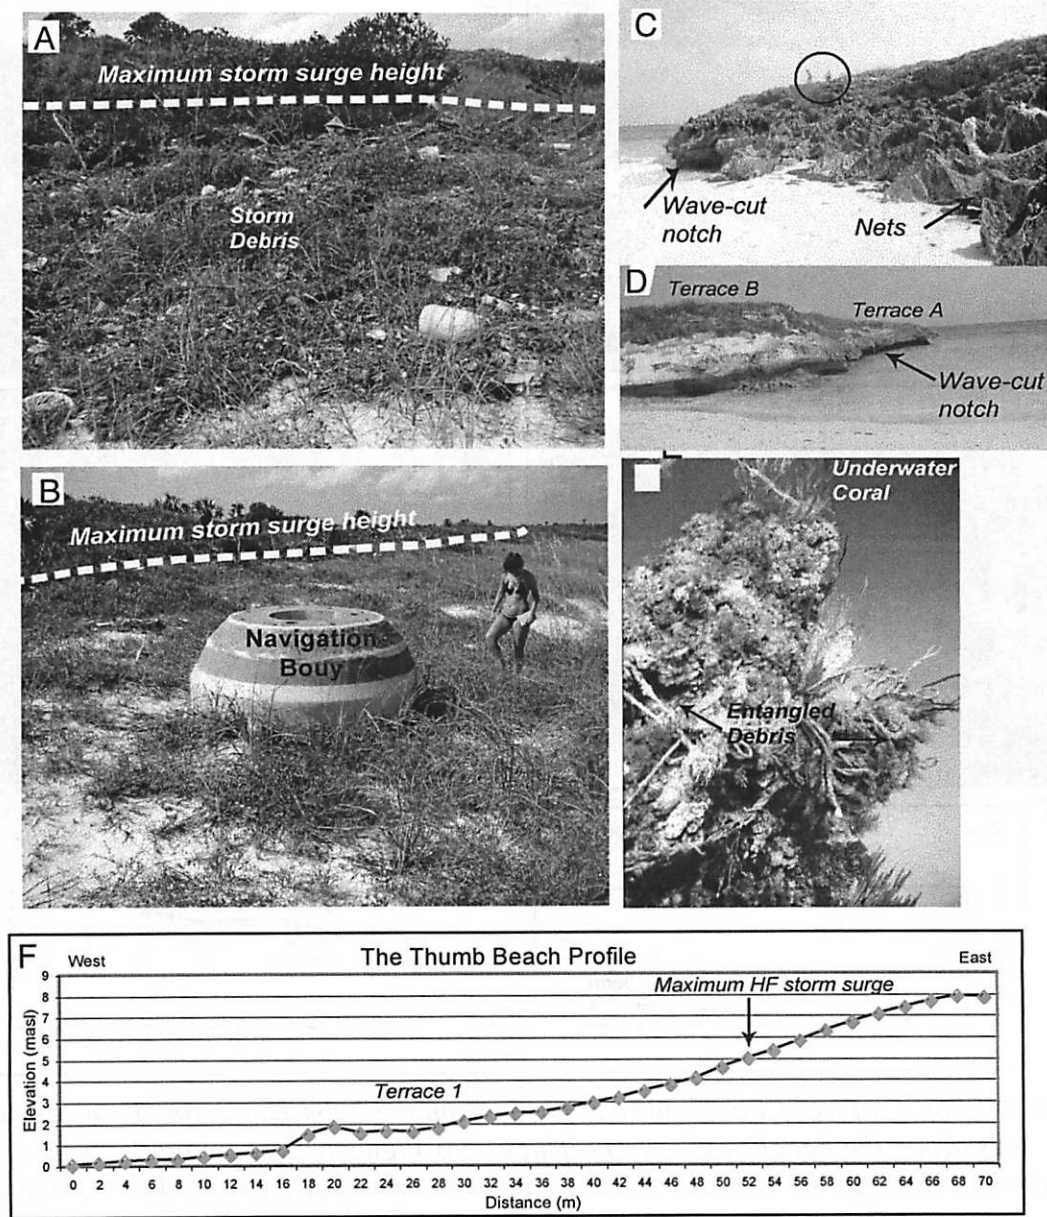
The Thumb. An areally expansive deposit of flotsam and jetsam has accumulated along the southwestern side of the spit and sand dune connecting the Thumb to the shore (Figures 5A and 5B). The debris includes ropes, buoys, plastics of all types, and what appears to be a portion of a large navigation buoy. A maximum Hurricane Frances storm surge height of 4.9 m was measured at this location by leveling to the upper limit of the flotsam and jetsam.

The beach profile at this site shows one distinct terrace level (terrace 1; Figure 5F). Hurricane Frances and previous storm debris are concentrated on terrace 1. This terrace is a flat surface covered predominantly by grass that lies at an approximate elevation of 2 to 2.5 m above mean sea level. Below terrace 1 is the active beach berm that is characterized by sparsely vegetated dunes and remobilized storm debris.

The bedrock outcrop of the Thumb is marked at its base by a prominent wave-cut notch (Figures 5C and 5D). This notch formed at mean sea level by erosion from wave action during the normal high and low tidal range. The weathered craggy outcrop above the notch is strewn with nets and ropes across the entire exposure indicating complete submergence of the bedrock knob during the hurricane storm surge and in previous storms. Two recognizable terrace levels can be seen in the bedrock profile (Figure 5D). The lower terrace A is a zone of bare rock outcrop formed about 1-2 meters above the notch. The upper flat terrace B is vegetated. This vegetation has been defoliated by the storm surge.

We surveyed the reef in the vicinity of the Thumb by snorkeling. An example of the state of the patch reef located just southeast of the end of the tombolo is seen in the underwater photograph of Figure 5E. The reef shows signs of damage with broken and overturned blocks. There are numerous entangled ropes, nets, and other debris caught in the reef. The entangled debris was likely brought to this and other sites along the eastern shore of San Salvador not just by Hurricane Frances but during numerous storms of lesser intensity that deliver trash entrained in currents of the North Atlantic gyre to this windward side of the island.

Figure 5: The Thumb is a southeast-trending tombolo located along the east coast of San Salvador (see Figure 3 for map location). A) Photograph of the large amount of flotsam and jetsam accumulated along the southwestern side of the spit and sand dune connecting the Thumb to shore. View to the west with the maximum storm surge height marked. B) View northward of the debris collected on the coastal dunes showing the maximum height of debris marking the storm surge height. C) The bedrock outcrop of the Thumb is marked at its base by a prominent wave-cut notch. The weathered craggy outcrop is strewn with nets and ropes across its height indicating submergence of the bedrock knob during the hurricane. View to the west. Circle marks two persons for scale. D) View of the south side of the Thumb showing the wave-cut notch and two terrace levels. The vegetation has been defoliated by the storm surge. E) Underwater photograph of a patch reef just to the southeast of the end of the tombolo showing damaged reef with numerous entangled ropes, nets, and other debris. F) Beach profile from the base of The Thumb on the west to the top of the coastal ridge on the east. The position of the maximum Hurricane Frances (HF) coastal debris from the storm surge is marked at a height of 4.9 m.

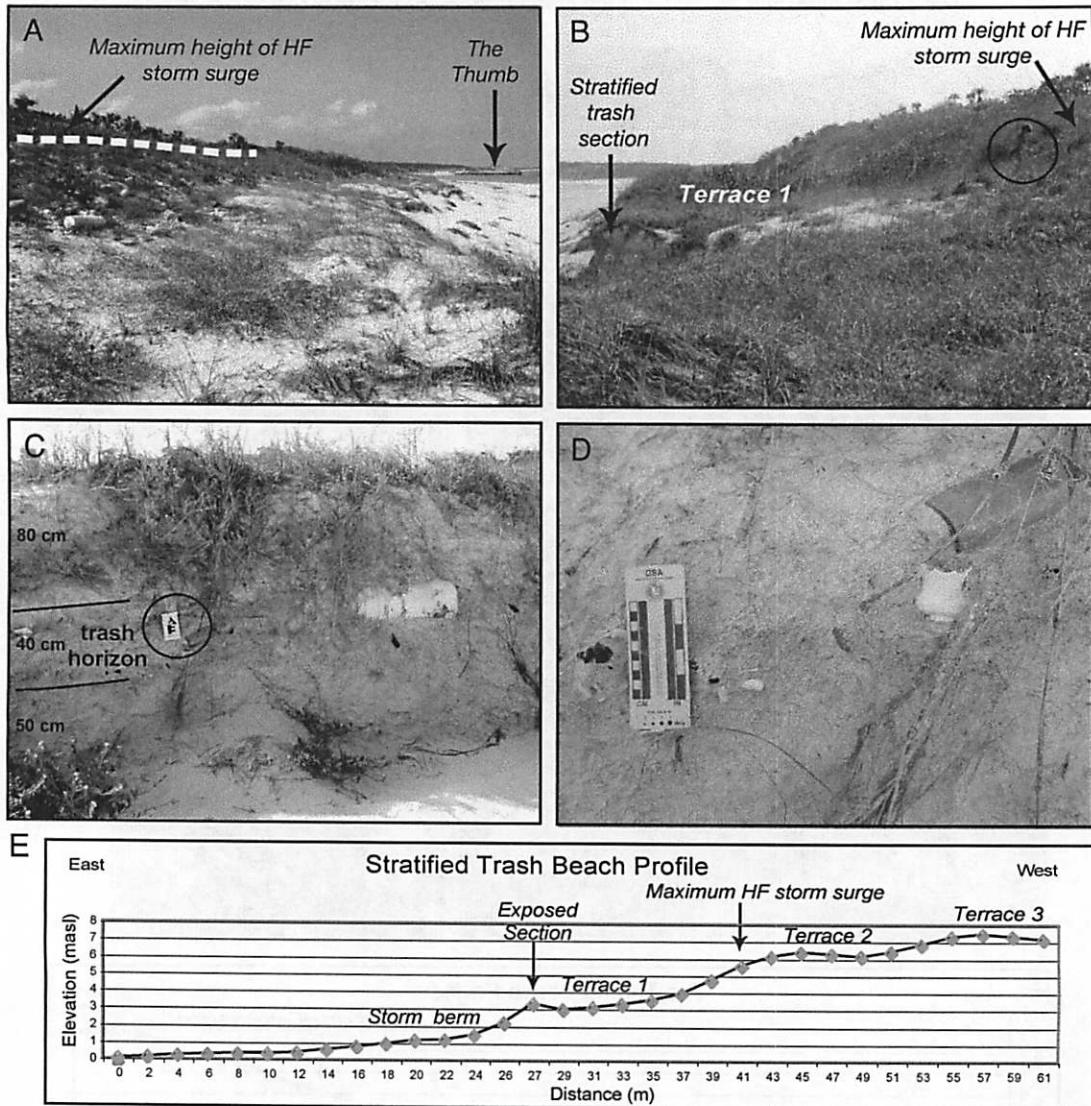
We measured a beach profile at this site (Figure 6E) that shows three terrace levels. The maximum storm surge height of Hurricane Frances at this location based on the upper elevation of flotsam and jetsam was measured at a height of 5.5 m. A heavy accumulation of Frances storm surge debris is also noted across the lower terrace 1. Terrace 1 lies at an elevation of about 3 to 3.5 m above mean sea level. It is broadly equivalent to the low terrace observed at the Thumb but at a slightly higher elevation. The terrace is vegetated predominately with coastal grass. Two upper, higher terraces (labeled terrace 2 and terrace 3) are stabilized with thick vegetation and trees. One lower bench in the profile is a storm berm formed after Hurricane Frances.

Erosion of the back beach area exposed a 170-cm-thick stratigraphic section that marks the eastern edge of terrace 1. The section (Figures 6C and 6D) contains a lower 50-cm thick section of aeolian sand overlain by 40-cm-thick layer of trash and storm debris. The section is capped by an 80-cm-thick bed of aeolian sand. The top surface of the section is the grass-vegetated terrace 1 surface. The stratified trash indicates that debris from a previous storm or hurricane was deposited

Figure 6. Photographs of storm surge deposits from the 2004 Hurricane Frances and other hurricanes along the beach south of The Thumb. A) View north showing the trash deposited from the storm surge. B) The Hurricane Frances storm surge deposited flotsam and jetsam across terrace 1 to a maximum height of 5.5 m. The circle marks a person for scale. View toward the south. C) Erosion of the backbeach dune exposed a 170-cm-thick stratigraphic section showing storm debris from a previous event interbedded with aeolian sand. Scale within the circle is 15 cm. D) Detailed view of the stratified storm deposit showing plastic fragments and objects, charcoal, a glass bottle, a light bulb and other trash. E) Beach profile showing the maximum storm surge height of Hurricane Frances (HF) based on the upper elevation of flotsam and jetsam. The stratified trash section in photos C and D marks the eastern edge of Terrace 1. One lower bench in the profile is the post-hurricane accumulation of a storm berm. Two upper, higher terraces (labeled terrace 2 and terrace 3) are stabilized with thick vegetation and trees. Location of the beach profile is shown in Figure 3D.

in this back-beach berm and then subsequently buried by windblown sand. A close-up photograph of the stratified storm deposit shown in Figure 6D highlights the various objects found in the tempestite including plastic materials of all types, charcoal, a glass bottle, a light bulb, and other trash (Figure 6D). The exposed stratigraphic section indicates that terrace 1 was built from deposition of previous storm events and modified by aeolian deposition. At this location Hurricane Frances deposits were found at higher elevations. These data suggest that the Hurricane Frances storm surge may have been more intense than the previous storms that hit the island in the recent past.

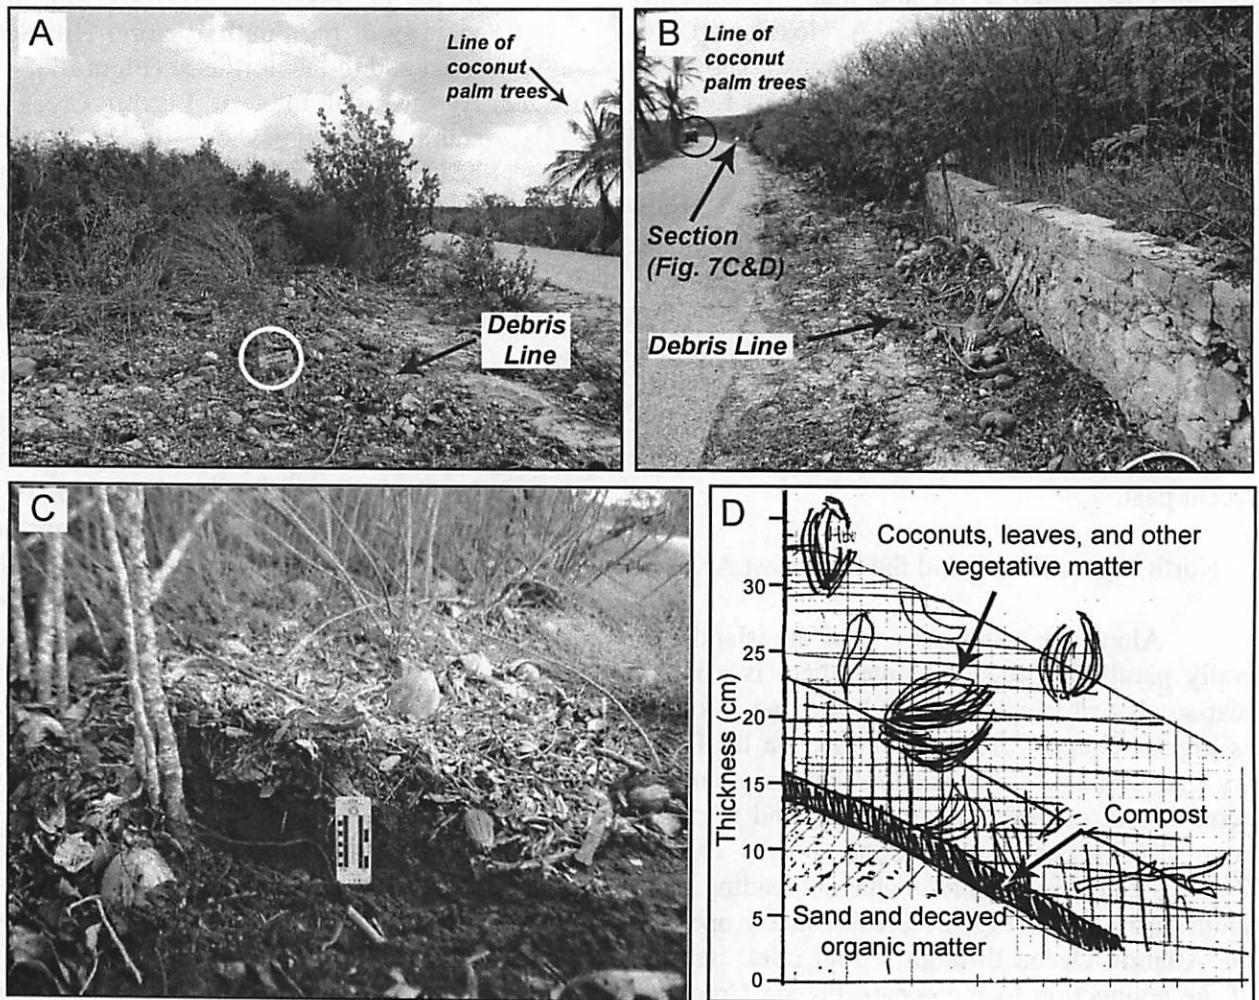
North Pigeon Creek. Along the northern end of Pigeon Creek (Figure 3C), water overtopped the normal shoreline leaving a line of debris marking the high water mark. At the northeast corner of the estuary, water surged out of the lake causing defoliation of vegetation and an overwash into two small ponds located north of the road (Figure 3B). In the area of the abandoned South Victoria Hill settlement, the maximum high water level was marked by a 1- to 2-m-wide debris pile that ringed northwest Pigeon Creek about 15-20 m inland of the normal shoreline (Figure 7).

We hand dug a trench through the debris pile at a site (GPS coordinates: 24° 00.726 N, 074° 28.250 W, with an elevation of 3 m) just south of the extant buildings of the settlement and south of the pier (Figure 7). The debris pile is made almost entirely of organic matter. A stratigraphic section drawn through the 33-cm-thick debris pile (Figure 7D) shows four layers. The upper 10 cm was largely leaves, palm fronds, sticks, roots, coconuts, and other vegetative matter overlying a 5- to 7-cm-thick mixed layer of leaves and composted organic debris. These upper layers rest on a moist thin layer of compost and a basal layer composed of medium-grained sand mixed with decayed organic matter.

It is clear that during the six months between deposition of the storm debris and the time of these observations that the material had already heavily decayed. There was a noticeable absence of any material other than sand and organic debris. No plastic debris or other man-made materials were present. The large number of coconuts in nut palm trees that grow along the east side of the

Figure 7. Water overtopped the normal shoreline of the northern end of Pigeon Creek leaving a largely organic debris pile marking the high water mark. (See Figure 3 for location map). A) View north showing the debris line on the west side of the road in the South Victoria Hill Settlement area of north Pigeon Creek. Circle outlines 10 cm photographic scale. B) View south showing the organic debris high water line east of the road and against an old wall of the South Victoria Hill Settlement area. Circle outlines a vehicle for scale. C) Hand-dug section exposure through the debris pile. The large number of coconuts in the debris are derived from a line of palm trees located on the east side of the road. View toward the north. D) Stratigraphic section drawing through the debris pile. The organic material is predominantly palm, mangrove, and other leaves, sticks, coconuts and other organic material that has decayed and composted. Drawing by Tani Sutherland.

road at this location (Figure 7). The other organic matter also has a local source. The mangrove and coastal vegetation surrounding this area of Pigeon Creek has been visibly defoliated. The stripped leaves were deposited in the debris pile.

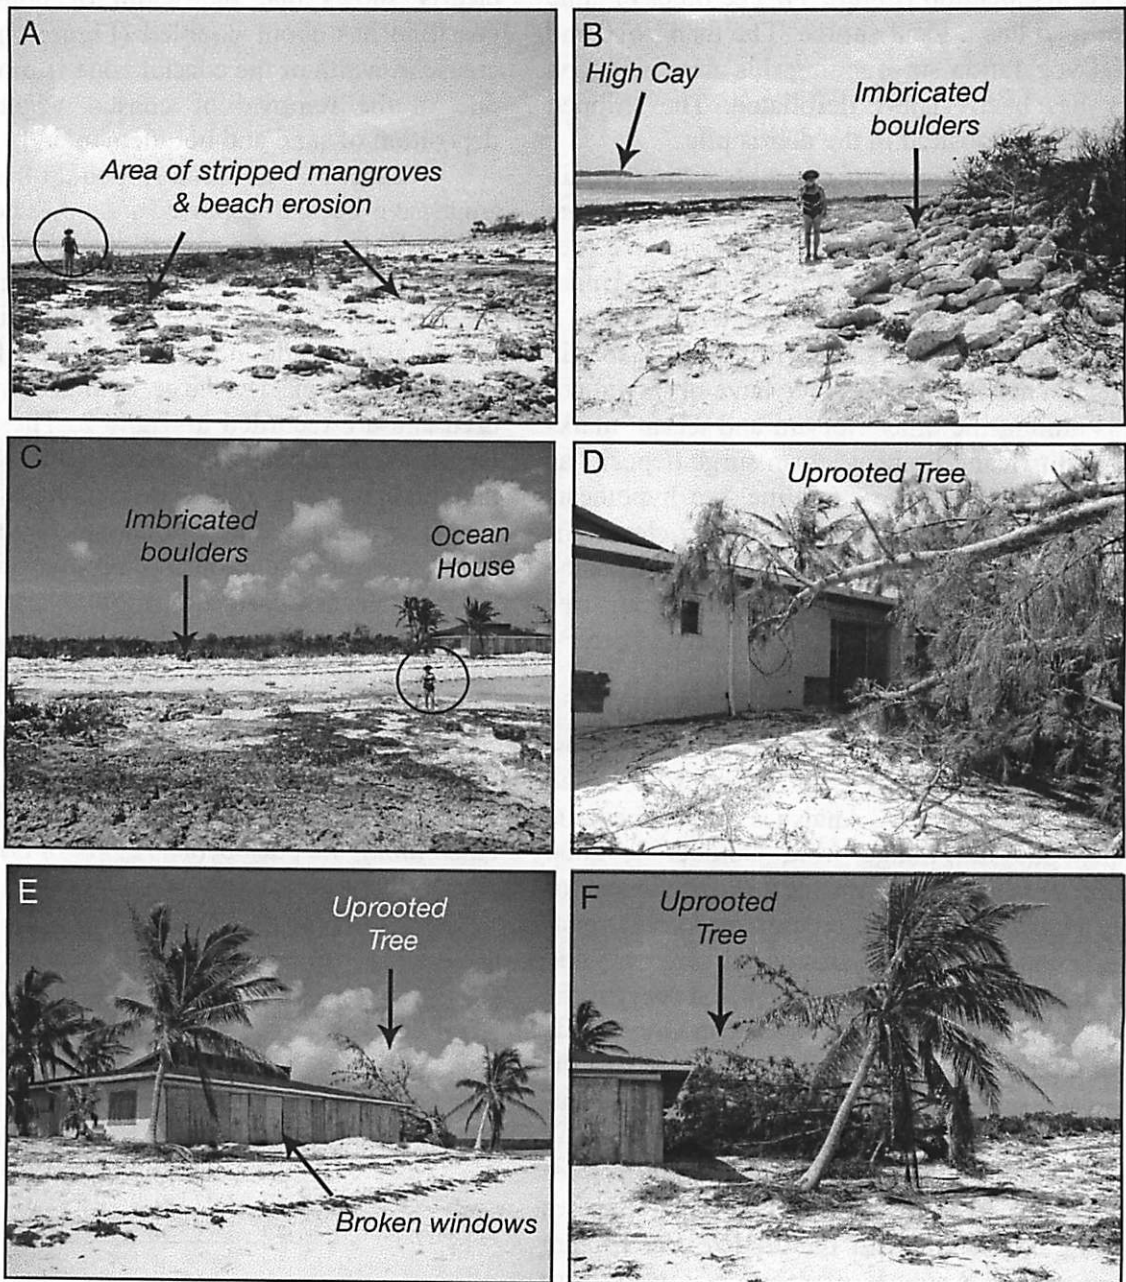
At low tide an area is exposed that measures about 70 m wide that contains remnants of mangrove roots and plants (Figure 8 A-C). Boulders are strewn over the surface. Some areas show signs that they have been newly exposed based on the lack of surface weathering. Examination of the satellite imagery from before (August 30, 2004) and after (October 1, 2004) Hurricane Frances

Large slabs of rock ripped up from the surf zone have been transported inland. The boulders are stacked with a dip toward the east. This imbrication indicates the boulders were transported to the west. The boulders were of local origin. Individual slabs could not be traced back to their original location. Ten large boulders were measured and are recorded in Table 2. The maximum length of the boulders is nearly 1 m (98 cm) and the average length of the boulders measured is 77 cm. If we assume that the classic Hjulstrom diagram that plots relationship between the stream velocity necessary to transport a particle of a given diameter is applicable to wave storm surge velocities, then a particle with an average length of 77 cm would require a water velocity in excess of 600 cm/s.

There was evidence of past imbrications, aligned in the same orientation as the boulders from Hurricane Frances. These boulders are seen in the background of Figure 8A and 8C and are covered with a black patina from algae, implying that these boulders are part of the supratidal zone (Hinman, 1994), and were transported in previous storm surge events.

Figure 8: Erosion and hurricane damage to Ocean House located at the tidal inlet of Pigeon Creek on the southeast side of San Salvador Island (See Figure 2 and 3 for map location). A) View south across the area of stripped mangroves and beach erosion. B) Imbricated boulders stacked along the back beach area. View southwest with High Cay island in the background. C) View northwest across the eroded platform that was stripped of mangroves. Ocean House in the background. Person for scale. D) Uprooted Australian pine tree (*Casuarina equisetifolia*) on the north side of Ocean House. E) View north showing the damaged Ocean House. F) View west of a tilted palm and toppled Australian pine tree.

cated at the Pigeon Creek tidal inlet. This property is known as Ocean House and is shown in Figure 8. The house was built without pilings and just above sea level. The windows throughout the house were knocked out and the storm surge is likely to have swept through the structure. An Australian pine (*Casuarina equisetifolia*) tree on the north side of the house was uprooted and fell toward the house.

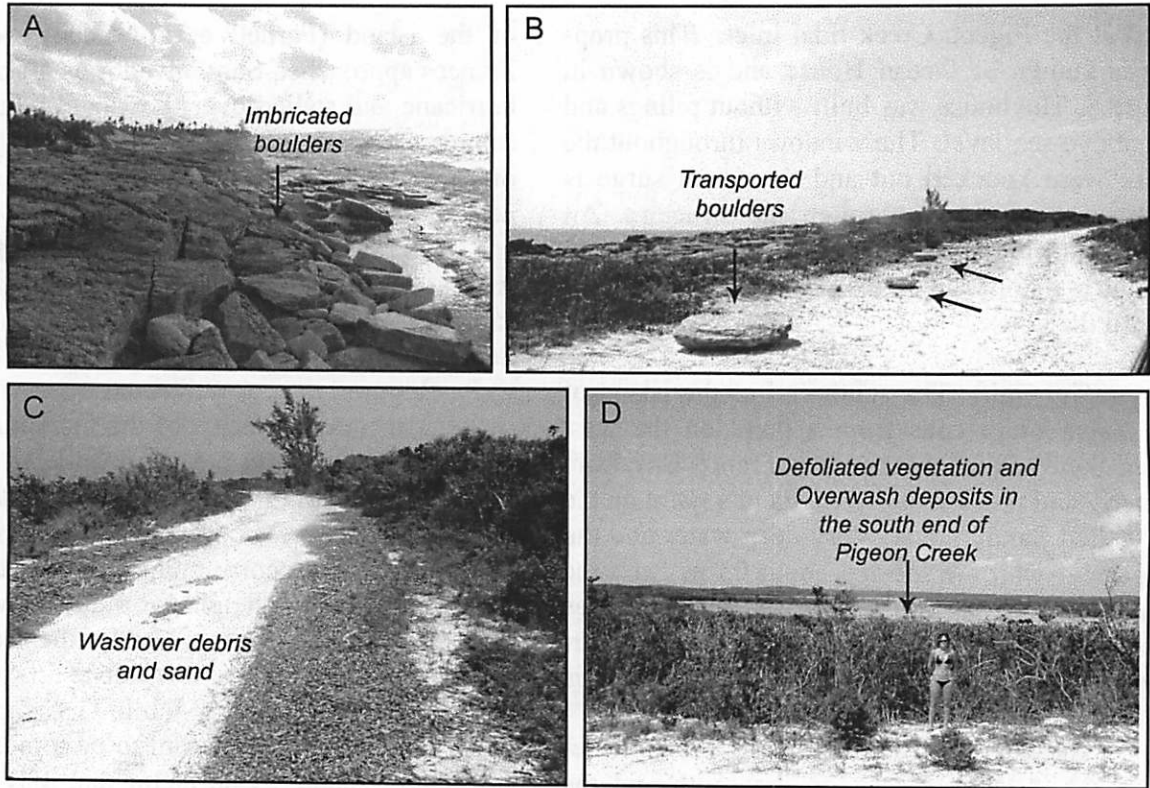
The width of the coast along the Gulf between the Atlantic Ocean on the south and the southern end of Pigeon Creek is very narrow measuring only about 75 - 100 m. We documented several locations with a series of photographs showing the effects of Hurricane Frances along the coastal zone of the Gulf. Large slabs of bedrock are broken and imbricated with slopes toward the south the result of numerous storms that batter the coast (Figure 9A). Some boulders larger than 1 m in length were transported as much as 50 m inland and were deposited along the road (Figure 9B). The storm surge came on shore and stripped the coastal vegetation of foliage. Sand, vegetation, and flotsam and jetsam were deposited on the coastal road (Figure 9C). At two locations, sand and other storm debris washed into the south end of Pigeon Creek forming an overwash fan (Figure 9D).

Figure 9. The Gulf is a site located along the south side of San Salvador island where the fringe reef and deep water lie close to the shore line. (See Figure 3 for a location map). A) Photograph along the coast showing imbricated large bedrock slabs and boulders. View to the east. B) Hurricane Frances transported large boulders from the shoreline onto the adjacent road. View to the west. C) In addition to buoys, ropes, plastic and other flotsam and jetsam, the washover debris included large amounts of leaves and organic material stripped from the coastal vegetation and sand. This photograph shows some of the overwash debris. View to the west. D) Overwash sediment was deposited into the southern end of Pigeon Creek. Defoliated vegetation marks the location of where the storm surge passed.
