PROCEEDINGS
OF THE
THIRTEENTH SYMPOSIUM
ON THE
NATURAL HISTORY OF THE BAHAMAS

CASUARINA-INDUCED BEACH EROSION REVISITED

Neil E. Sealey
 PO Box N-10736
 4 Montagu Avenue
 Nassau
 BAHAMAS
 nsealey@coralwave.com

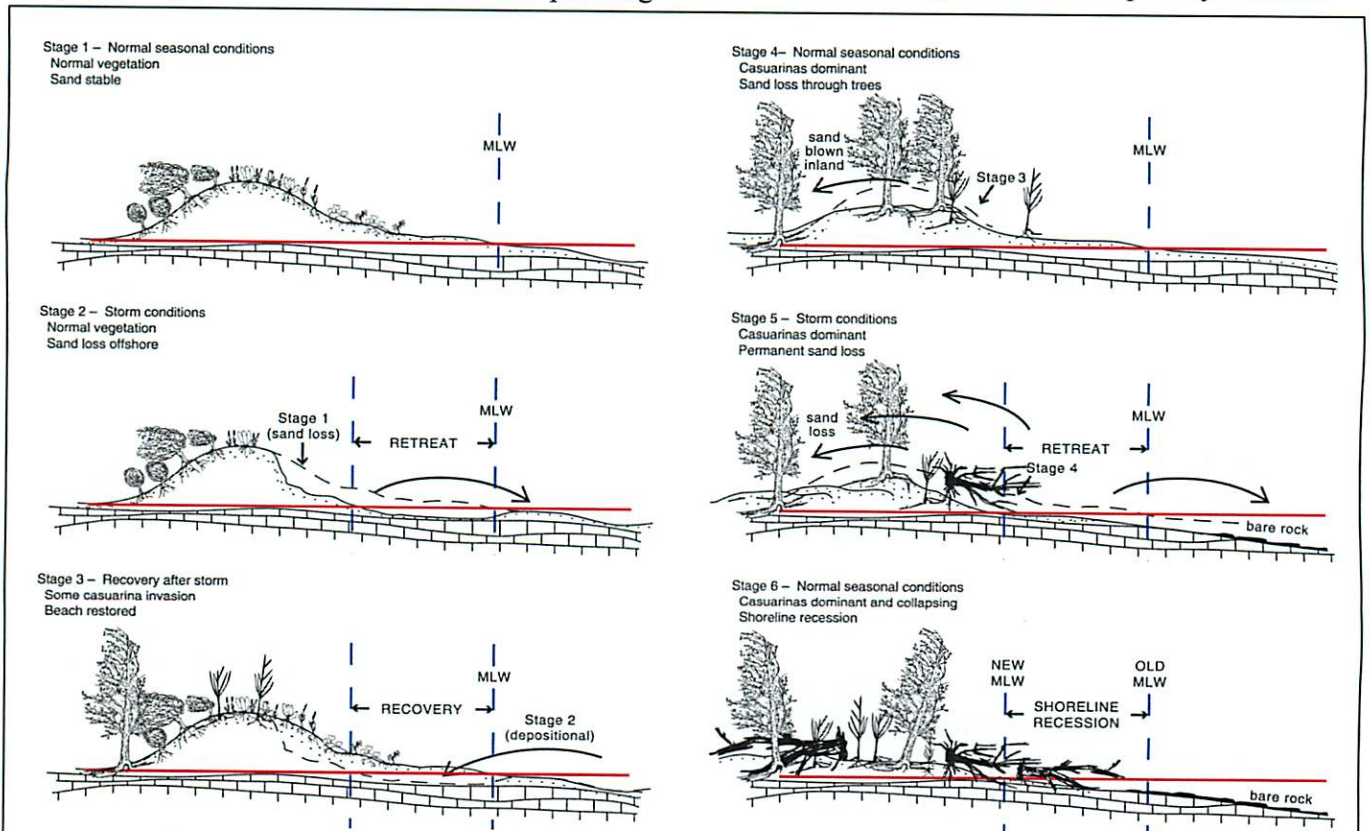
Figure 1. The stages of the cycle showing the transition from stable beach and dune to eroded and retreating beach. (MLW = mean low water mark).

North Andros, but using observations and other studies from around The Bahamas, the hypothesis was made that the Casuarinas invaded cleared or damaged land. Once established, which doesn't take long, the Casuarinas suppressed the local vegetation due to their poisonous impact on the ground around them. This resulted in bare sand under the trees which under storm conditions was washed inland, and lost from the beach and dune forming processes. This caused beach recession,

and the sacrificial presence of the Casuarinas ensured that this became a permanent state as long as the Casuarinas reseeded themselves and occupied the foreshore (Figure 1).

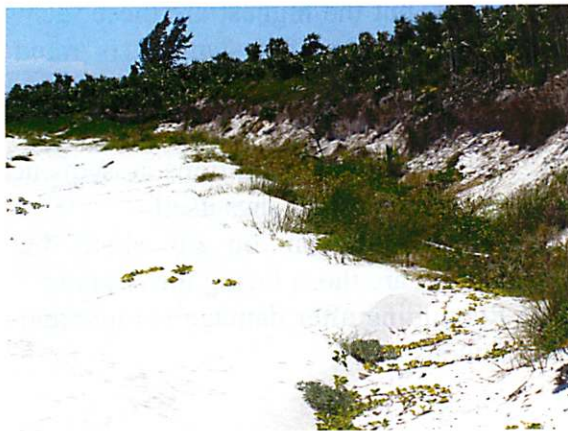
Figure 2. Normal reconstruction of eroded dune without casuarinas on Windermere Island.

- The Small Hope Bay investigation suggested that this was due to the suppression of other vegetation beneath the trees.
- This led to sand blown onshore not being trapped to form dunes.
- The ideal situation under storm conditions is for sand from the face of a dune to be transported offshore. It is then available to rebuild the beach when normal conditions return (Figure 2).

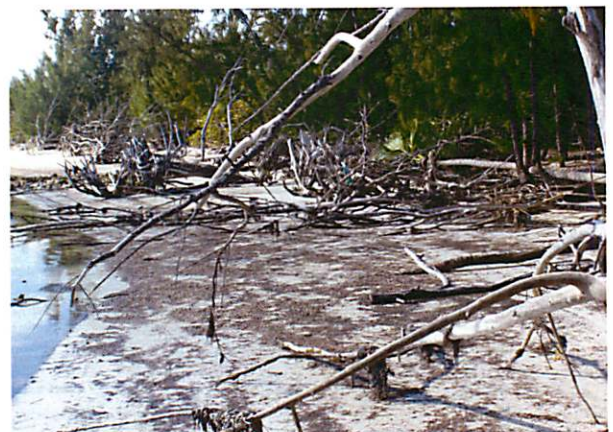
Figure 3. Chronic erosion and shoreline retreat after loss of dune at Small Hope Bay, North Andros.

Casual observation of a number of shorelines show extensive Casuarina presence, and in most cases these shorelines are eroding. The Small Hope Bay investigation suggested that this was due to the suppression of other vegetation beneath the trees, although this may not be total. This led to sand blown onshore not being trapped to form dunes, so that during storm episodes there was nothing to stop massive beach erosion and sand loss onshore, where it stayed. These sites show Casuarina presence and erosion. The ideal situation is sand from the face of a dune being transported offshore where it is available for return to the beach when normal conditions return (Figures 3 and 4). A report from a developer in the Turks and Caicos, who had read the Small

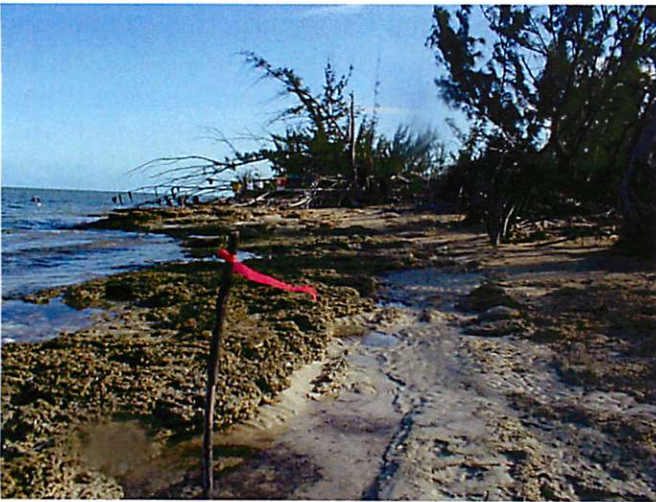
Figure 4. Total loss of beach and dune at Blanket Sound, North Andros

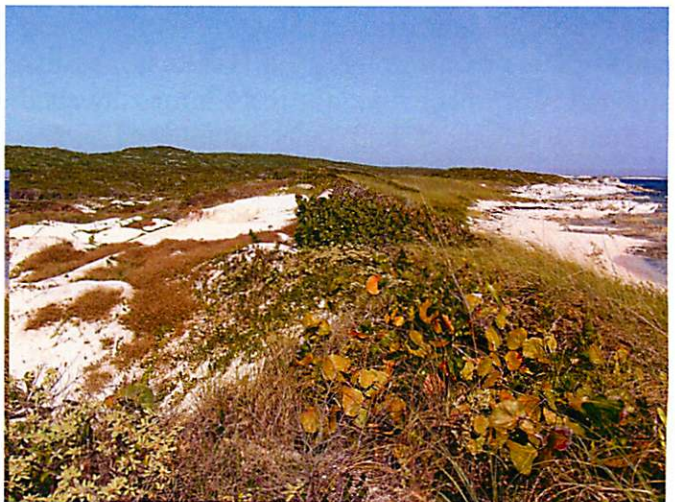
Figure 6. Well-developed beach/dune system on Long Island. Sand removal in left foreground may cause future problems.

Fortunately there are still a number of these in The Bahamas, not least on San Salvador. The details of East Beach and its recovery after storms have been studied and detailed elsewhere (Beavers et al, 1995), but similar beaches exist along many shores, including Cat Island and Long Island (Figures 5 and 6). Under normal conditions a sequence of vegetation establishes itself, leading to the formation of a sand dune. Dunes will form on any shore, but the highest are those facing the Atlantic. Rebuilding after damage is rapid and continuous.

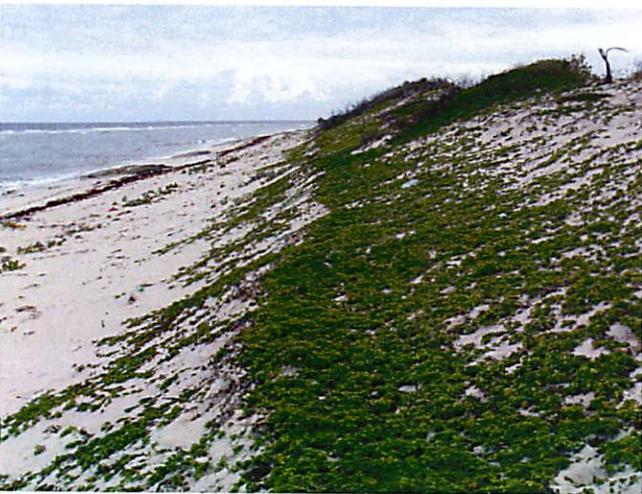
Figure 5. Stable dune and beach without Casuarinas on Rum Cay

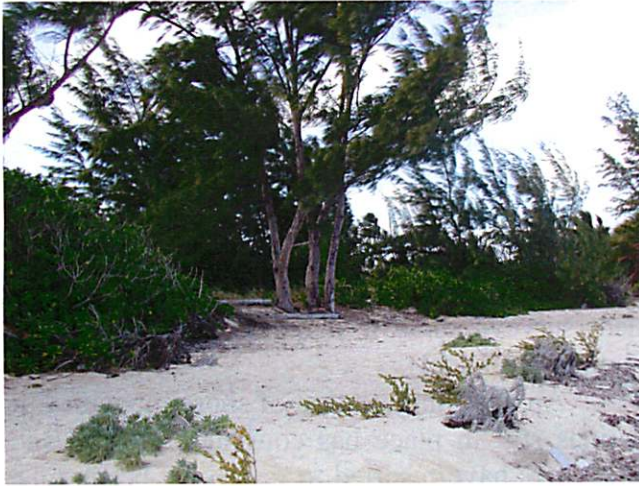
Figure 7. *Casuarina* invasion causing erosion in healthy beach at Staniel Cay, North Andros.

While the mere presence of *Casuarinas* dominating a beach and associated with erosion does not necessarily prove that *Casuarinas* were responsible, the presence of erosion associated with *Casuarinas* on a beach that also has a natural dune with native vegetation is instructive. In these cases we can see that the *Casuarina* areas are hollowed out and contain little native vegetation. In most cases these areas have not accumulated sand and would be easily breached under storm conditions. Andros as usual provides good examples,

(Figure 7) but even in New Providence there is a surprising example on Paradise Island.

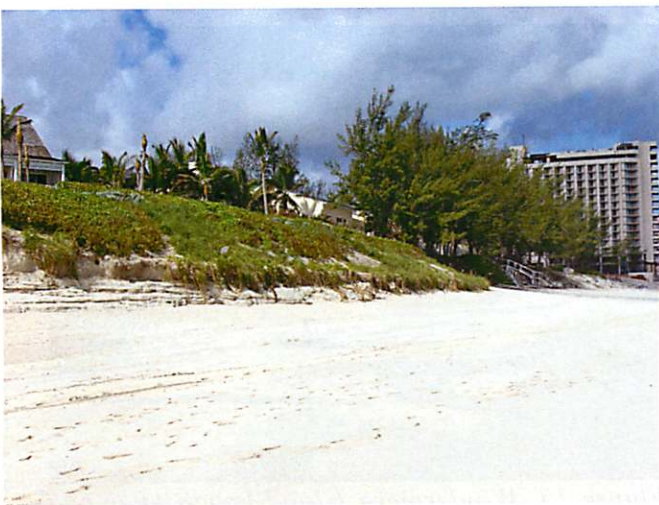
Figure 8. *Casuarina* intrusion and dune retreat within stable dune on Paradise Island.

Despite Atlantis's understanding of the nature of *Casuarinas*, which they removed en masse from all parts of their property in the 1990s, adjacent properties haven't learned the importance of natural vegetation, and between two Atlantis properties is an island of *Casuarinas* with accompanying erosion (Figures 8 and 9). Atlantis responds quickly to limited damage with beach scraping.

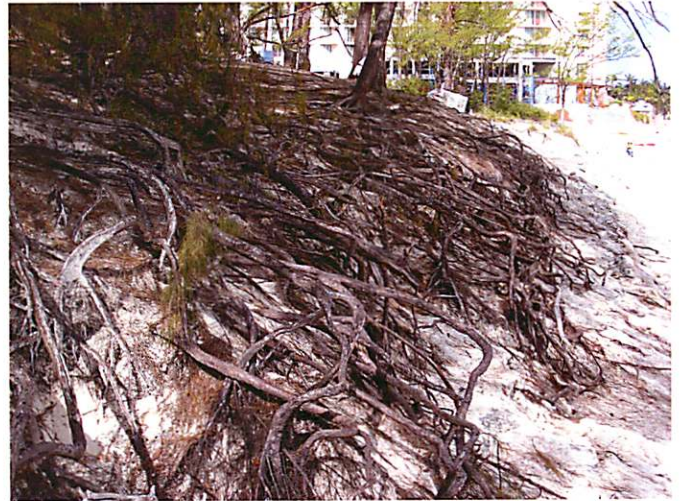
Figure 9. Chronic erosion of dune beneath *Casuarinas* shown in figure 8.

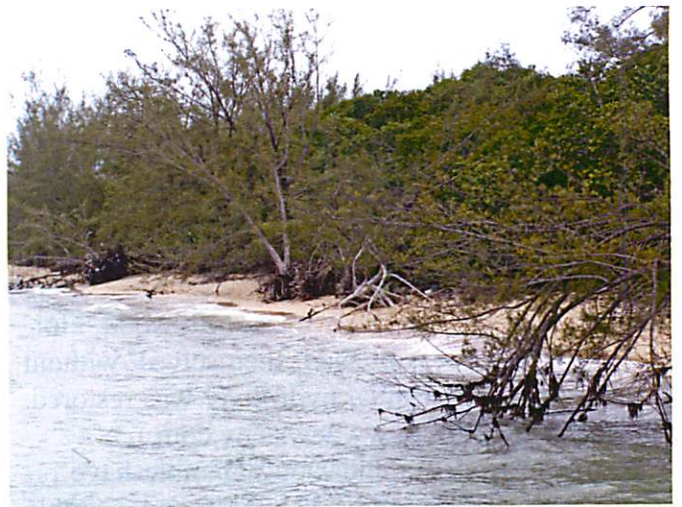
Figure 10. Loss of beach at South Ocean, New Providence. Adjacent area without *Casuarinas* is stable (Figure 11).

In the south of New Providence a popular public access point has classic Casuarina-induced beach erosion, but as soon as the adjacent Albany house is reached erosion has been stopped and there is clear evidence of accretion (Figures 10 and 11).

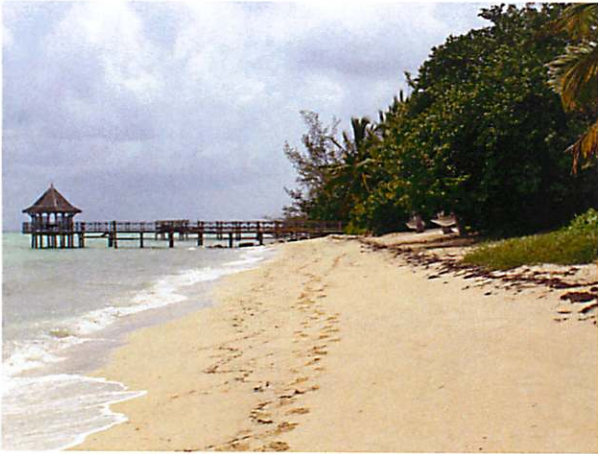
Figure 11. Healthy accreting beach immediately east of site in Figure 10 – Casuarinas visible in background.

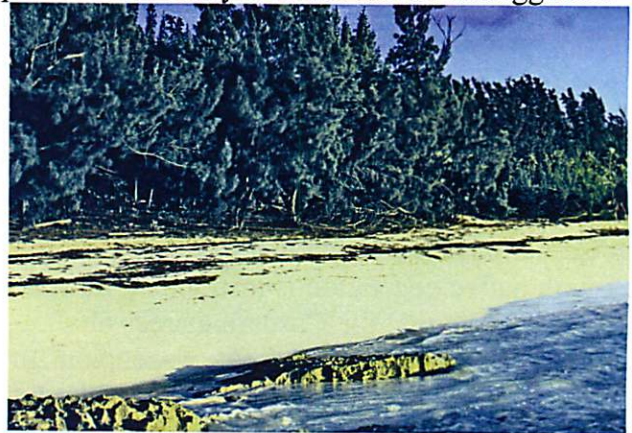
Figure 12. Windermere Island with dominant Casuarinas prior to 2004. (Photo: Carry Rich)

The northern end of Windermere Island is an interesting case. The proprietor came across a copy of the Small Hope paper and, recognizing an almost identical situation on Windermere Island, had all the trees on his property removed. Subsequent surveys show a stable or accreting beach (Figures 12 and 13).

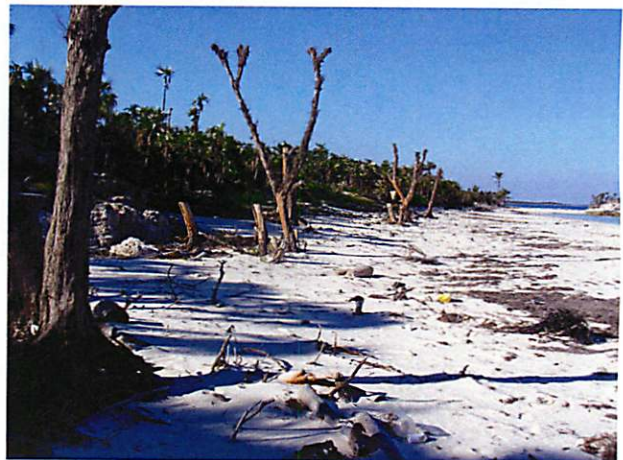
Figure 13. Windermere Island beach after Casuarinas removal. Note that beach now extends under and behind Casuarinas remains.

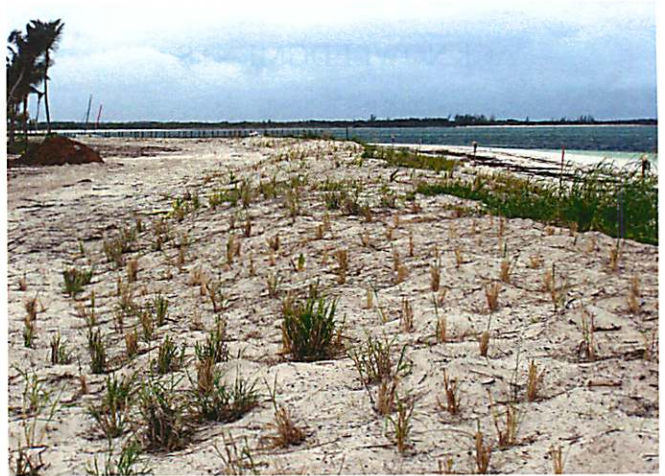
Figure 16. Replanting the beach with sea oats after *Casuarina* removal, Guana Cay, Abaco, 2005.

On Guana Cay on a south-facing shore, replanting after massive *Casuarina* removal with plugs of sea oats led to a steady regrowth and moderate sand accumulation. (Figures 14-16) The dune also aligned itself after planting where the plant line was not synchronized with tidal movement (Figure 17).

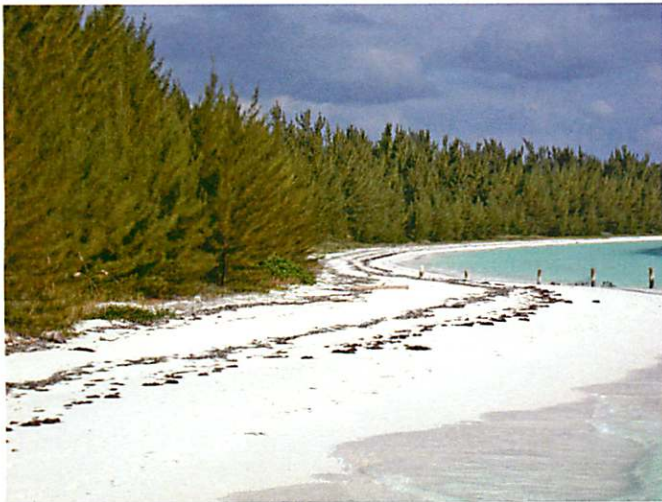
Figure 14. Massive *Casuarina* infestation of Disney site on Guana Cay, Abaco

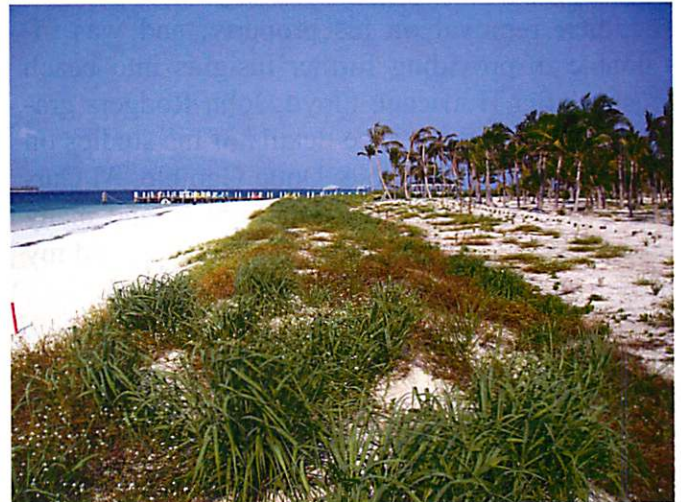
Figure 17. Reconstructed beach after removal of *Casuarinas*, Guana Cay, Abaco.

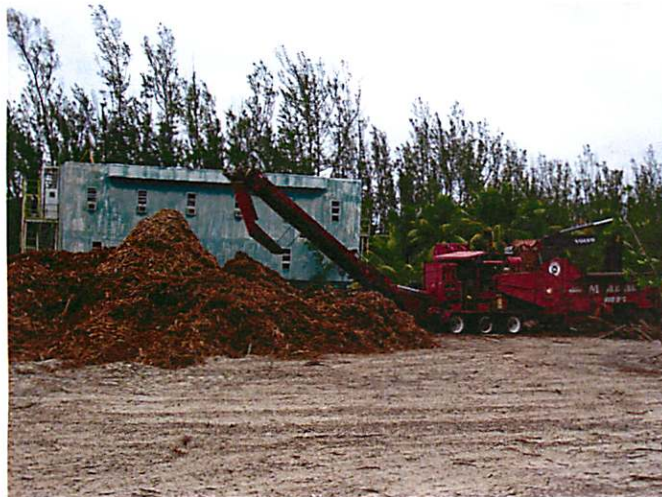
Figure 15. Aggressive removal of *Casuarinas* by developers of Guana Cay, Abaco, 2005.
