**NATURAL HISTORY AND GEOLOGY OF THE BAHAMAS**

**AERIAL PHOTOGRAPHY OF COASTAL EROSION AND LARGE BOULDER TRANSPORT  
FROM HURRICANE MATTHEW (2016) ALONG CLIFTON BEACH,  
NEW PROVIDENCE ISLAND, THE BAHAMAS**

John D. Rucker, Tina M. Niemi, Joseph A. Nolan, and  
Tori Rose

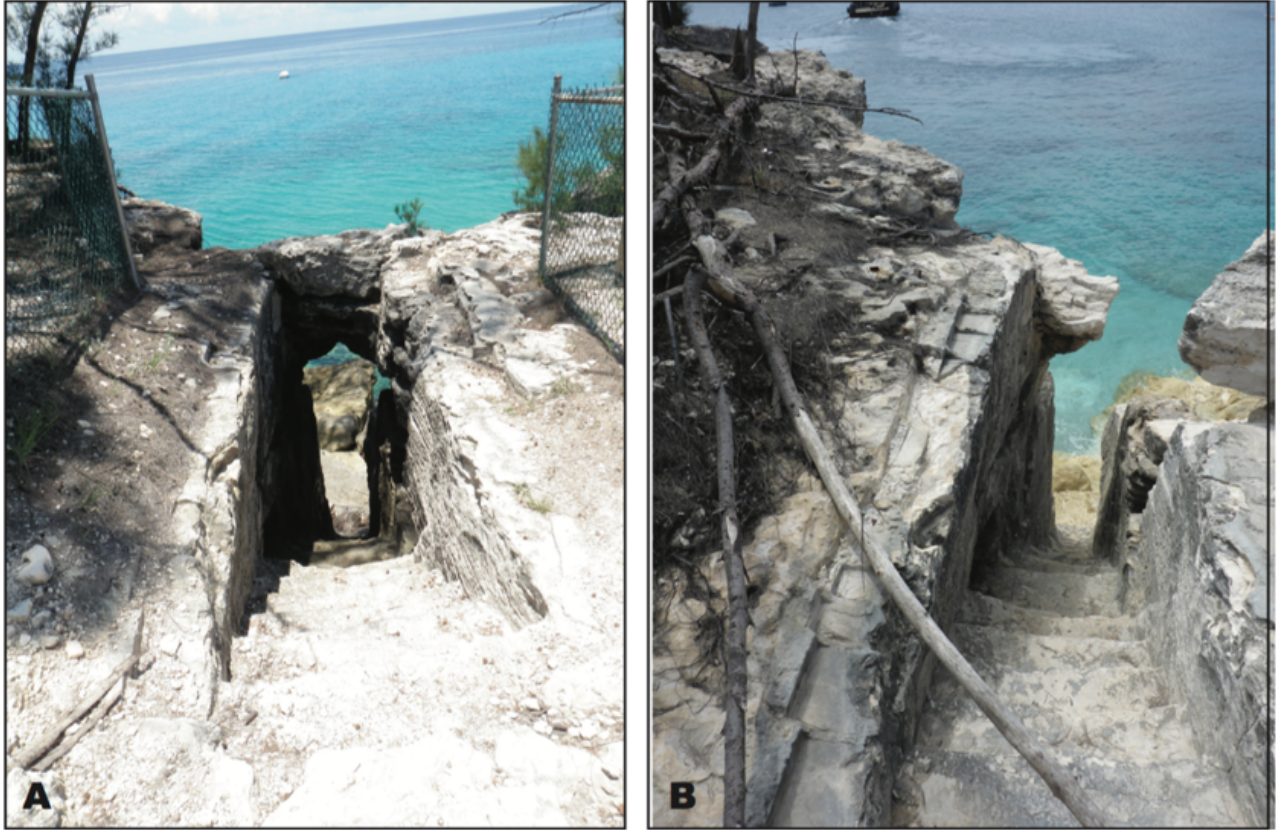
Figure 8: The Pirate Stairs near Clifton Pier showing damage from Hurricane Matthew. A) Photograph from June 2012, and B) Photograph from March 2017. Note the fence that once stood at the edge of the cliff and around the stairs in the 2012 image and the broken and transported lintel block.

At the nearby Pirate Stairs location (Figure 7), the topography has changed to a steep cliff exposure. Hand cut from bedrock, The Pirate Stairs create a path from a wave-cut platform at sea level about 6 m from the low tide level up to the top of the cliff (Figure 8). This cliff exposes the late Pleistocene rocks of the Cockburn Town Member of the Grotto Beach Formation topped by a *terra rossa* paleosol (Mylroie et al., 2012). The bedrock is a calcarenite with herringbone cross stratification and tabular and planar cross-beds which deposited in a subtidal to intertidal environment. Iron-rich red caliche line the vertical and horizontal fractures in the bedrock (Figure 8). These fractures form weaknesses in the bedrock that facilitate collapse and cliff retreat in storms.

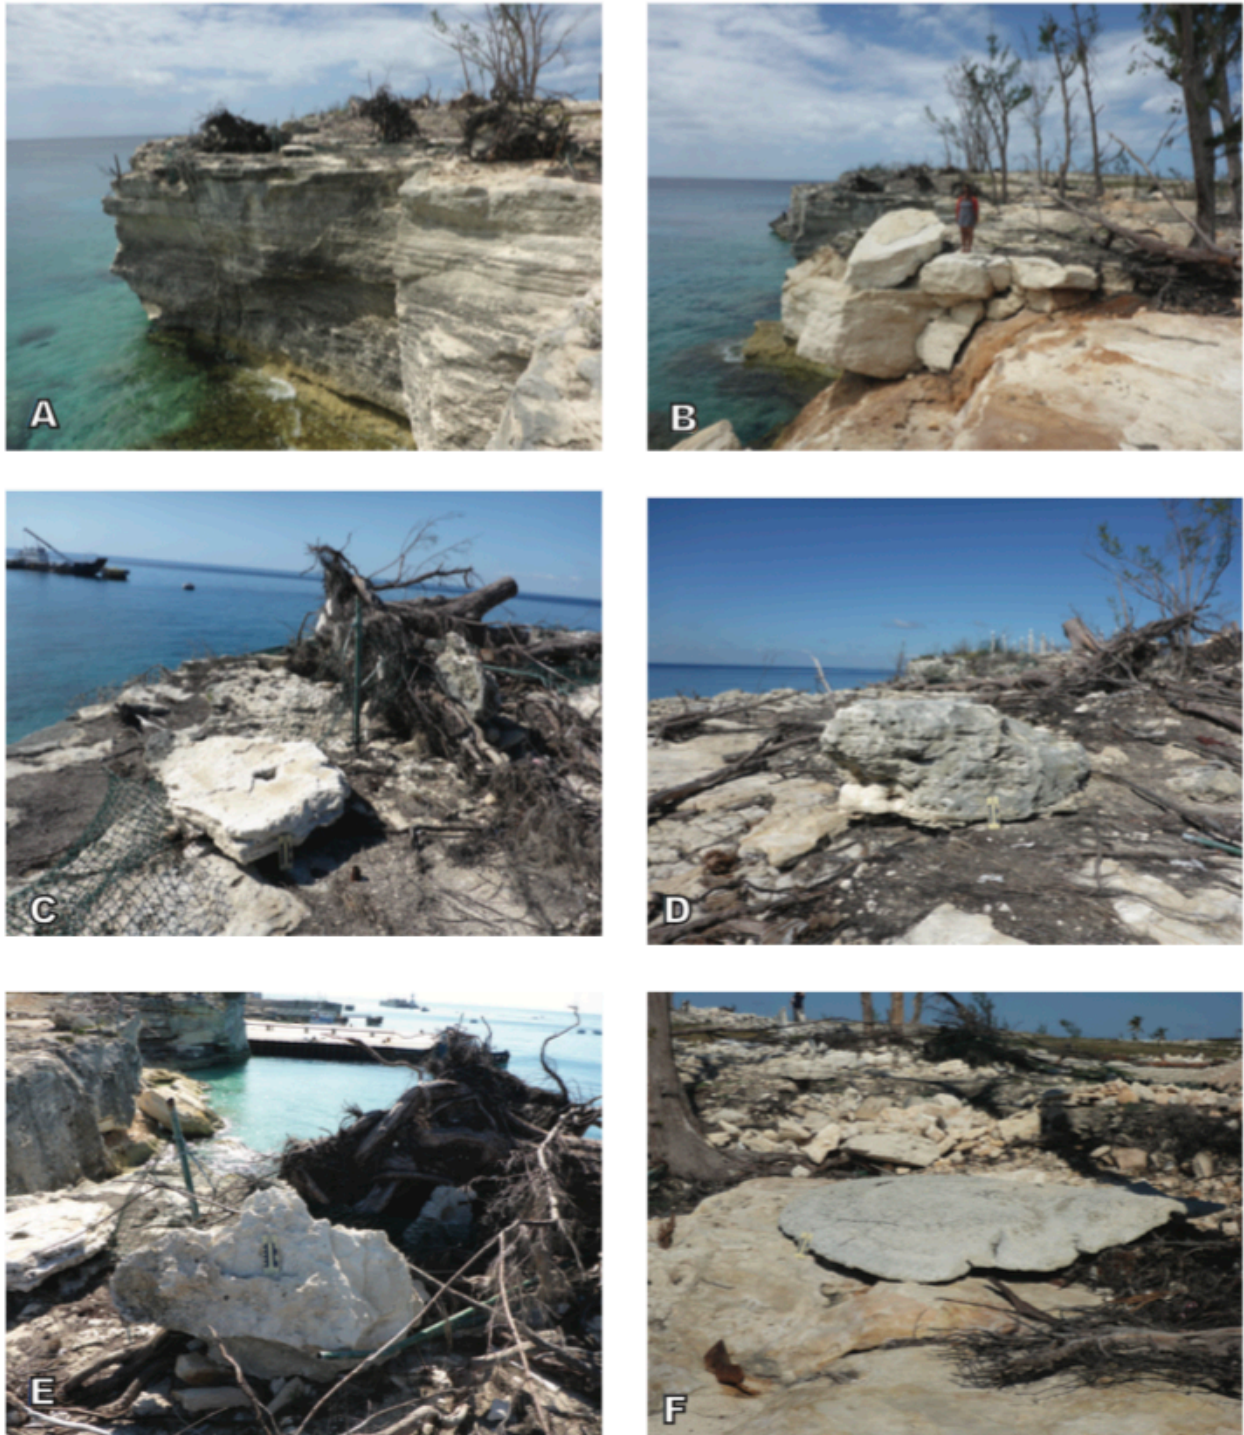
Figure 9: A) Cliff showing bedrock exposure immediately to the west of the Pirate Stairs. B) Very large boulder dislodged from top edge of approximately 6-m-high cliff, west of the Pirate Stairs (researcher for scale). Note the red caliche that lines the vertical and horizontal fracture surfaces. The unweathered surface of the cliff and boulders indicates recent collapse and movement. C) Boulder deposited on top of flattened fence. Also note uprooted *Casuarinas* Sp. D) Boulder moved inland and uprooted *Casuarinas* sp. E) Boulder deposited on top of remains of fence with uprooted tree and sea wrack. F) Waste concrete slab apparently lifted and slide inland. It's original location in approximately where the "F" is located on the image.

Along the top of the cliff, Australian pine trees (*Casuarinas* sp.) lay uprooted and large boulders (up to 6 m<sup>3</sup>) moved inland. Sea wrack, mostly brown seaweed (*Sargassum* sp.) became trapped in a fence toppled by boulders that subsequently rest on top of it (Figure 9 and 10). Boulders transported

by storm surge is evidenced by *Sargassum* found under boulders themselves. This is a strong argument against its arrival by some other means than storm surge. At this site, we recorded dimensions and orientation of several large boulders that showed clear evidence of recent movement. Table 1 provides measurements of some of the largest boulders. While there are many large boulders that moved inland by water at this site, there are two that stand out. First, the boulder that previously served as a lintel over the narrow stairway has broken off and shifted over on top of the broken base of the steel post that previously held the fence along the edge of the cliff. Other boulders are now sitting on other parts of this fence as well. Second is a large slab of concrete. We hypothesize that it was excess concrete out of a cement truck, possibly during construction of the fence. In any case this concrete formed a rough lens shape about 2 m by 3

m, but only about 20-30 cm thick (~1.8 m<sup>3</sup>). It originally formed in a slight depression in the bare bedrock. Based on marks in the bedrock, this slab slid about 2 m inland requiring very high wave energy.

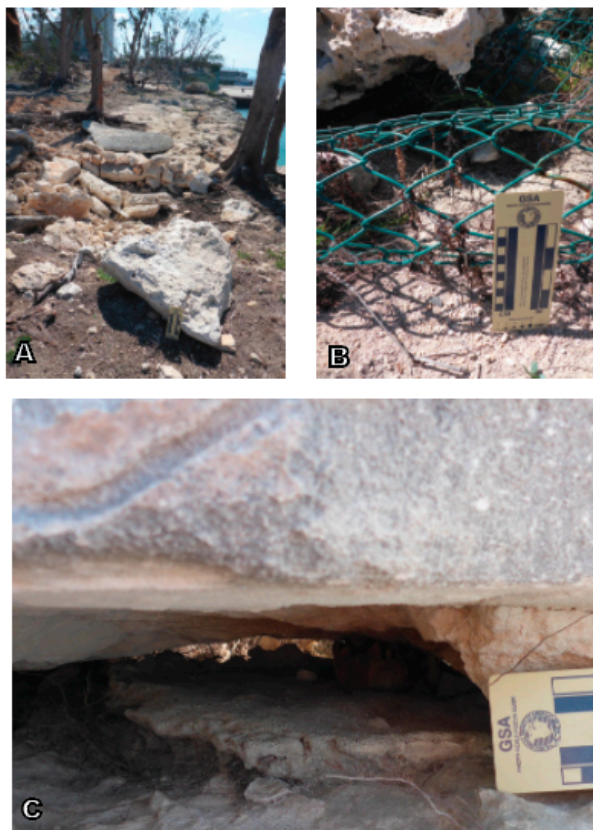
Figure 10: A) Small boulder apparently moved by rolling. B) Sea wrack entangled in the fallen fence. One of the boulders now resting atop the fence is visible at top of image. C) This is the very large slab of rock that previously formed the lintel over the Pirate Stairs. It has been shifted up, inland, and slightly to the west, and now rests directly atop the sheared off base of one of the metal fence posts (visible in the crevice). This slab is visible in Figure 8 A, as it originally rested, and the corner of it is visible on the right edge of Figure 8 B, in its post Hurricane Matthew location.

Second, at the Pirate Stairs, the boulders did not roll. In general, they are flattish slabs of bedrock, similar to an airfoil, that have been plucked loose and slid along. We hypothesize that the mechanism for this is that water is forced under them and lifts them on a cushion of water as they slide. This is particularly evident for the concrete described above. Also, the NOAA report on Hurricane Matthew records a 2.5 m storm surge on New Providence (Stewart, 2017). At the Pirate Stairs, we have clear evidence of boulder movement and flotsam and jetsam at the top of an approximately 6-m-high cliff. The reason for this discrepancy is likely an offshore storm surge focusing mechanism, probably the deep water immediately offshore.
