**PROCEEDINGS OF THE 13th SYMPOSIUM
ON THE GEOLOGY OF THE BAHAMAS
AND OTHER CARBONATE REGIONS**

IMPACT OF THE SEPTEMBER 2, 2004 HURRICANE FRANCES ON THE COASTAL ENVIRONMENT OF SAN SALVADOR ISLAND, THE BAHAMAS

Tina M. Niemi, Jamie C. Thomason, Janice M. McCabe, and Alexander Daehne

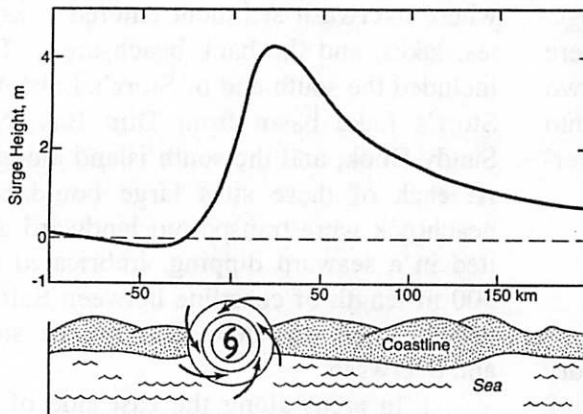
Our measurements of the maximum storm surge height of 4.8 to 5.5 m were determined by leveling to the highest evidence of flotsam and jetsam at locations along the east side of the island. These values correspond well with the upper limit of storm surge height for a Category 4 hurricane (Table 1). Tidal chart data for the island for 2 September 2004 indicate low tide at 5:06 p.m. and high tide at 11:11 p.m. (Mobile Geographics online). The tide does not seem to be a factor in the storm surge height. One factor that may have increased the storm surge height in this location to the right of the hurricane eyewall is the combined forward motion of the storm center adding to the onshore-directed winds (Figure 10; Liu, 2004).

Figure 10. Schematic diagram of the distribution of storm surge heights along a coastline relative to the landfall of the eye of an intense hurricane. The storm surge height is greater on the right side of a hurricane due to the combined forward motion of the storm center and the onshore directed winds. (Figure from Liu, 2004).
